Real-Time Micro-Explosive Damage Detection in an Unmanned Rotorcraft Vehicle Using Embedded Sensing

H. EDGE, H. CHUNG, M. COATNEY, B. MARY, P. TIBBITS,
M. MURUGAN, A. GHOSHAL, D. LE and M. PAPPAKOSTAS

Patrick Tibbits, Muthuvel Murugan, Michael Coatney, Brian Mary, Harris Edge, Aninidya Ghoshal, Dy Le: Army Research Laboratory, Aberdeen Proving Ground, MD 21005 Mark Pappakostas, Howard Chung: Acellent Technologies, Inc., 835 Stewart Drive, Sunnyvale, CA 94085

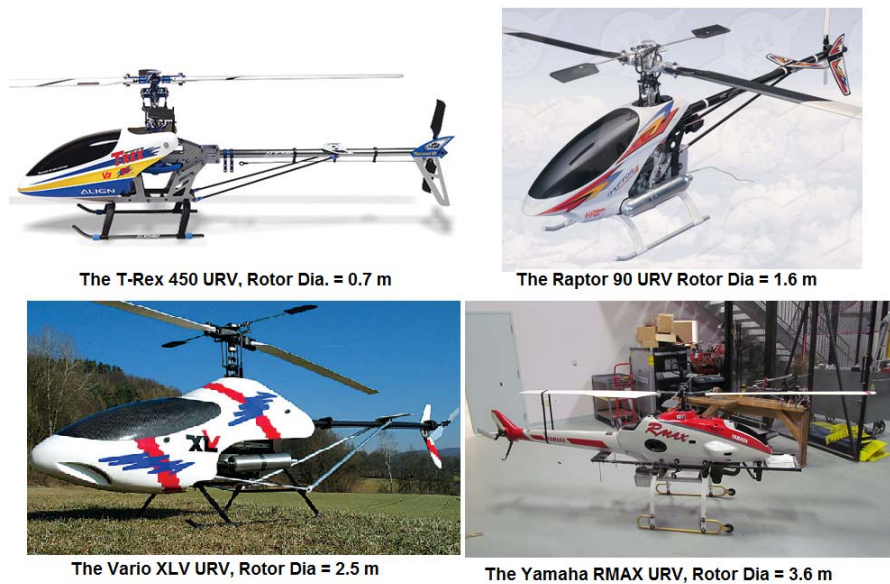
In collaboration with the ARL-VTD Mobility and Manipulation Team at the Aberdeen Proving Ground (APG), four URVs have been made available. The available URVs include the Yamaha RMAX, Vario XLV, Raptor 90, and T-Rex 450. The URVs are shown in Figure 1 and their development is described in [2]. One of the smaller URVs, the Raptor 90, is currently used to gain full confidence prior to incorporating flaws into selected PSEs using a larger URV. The Raptor 90 URV side plate structure was selected as the PSE to assess and demonstrate advanced sensor system capabilities for damage detection and damage growth monitoring. The

Figure 1: ARL Available URVs

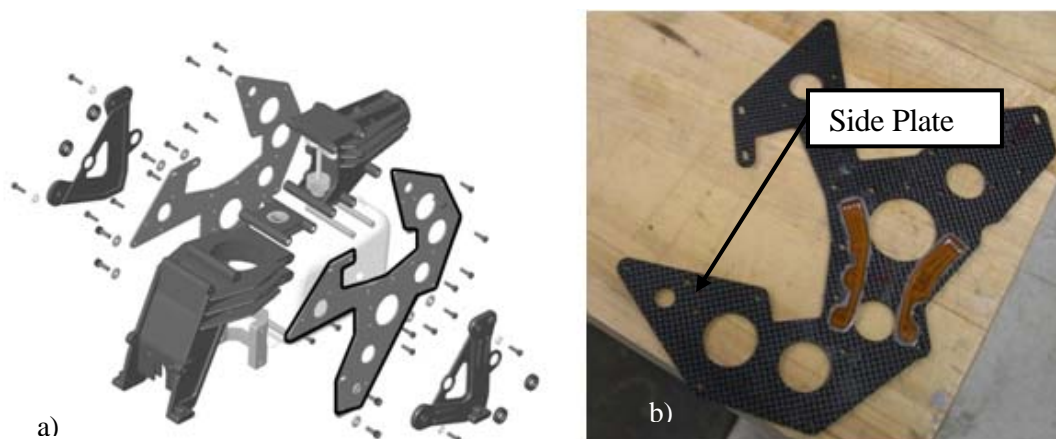
exploded view of the Raptor 90 airframe is illustrated in Figure 2 a), in which the side plate is indicated.

Figure 2: a) The Raptor 90 Airframe and Selected PSE b) The Side Plate with Sensors Installed

Acellent SMART Layer sensors [4-7] were selected and installed on a composite Raptor 90 side plate, after flaw creation, as shown in Figure 2 b). Each of the Kapton-based sensor strips contained three piezoelectric transducers capable of generating Lamb waves. Each transducer can detect the Lamb waves produced by the other transducers. The flawed, instrumented side plates were then connected to Acellent ground-based instrumentation, which interrogated the sensors and collected the resulting data. The data was examined with the Acellent SmartPatch software using time-history analysis to generate the damage image, Figure 5 b). To increase flexibility in sensor installation, which in turn facilitates optimization of sensor location, a version of the side plate was fabricated without lightening holes. The lightening holes are the seven largest holes which appear in Figure 2 b). Later iterations of this experimental effort will focus on this design.

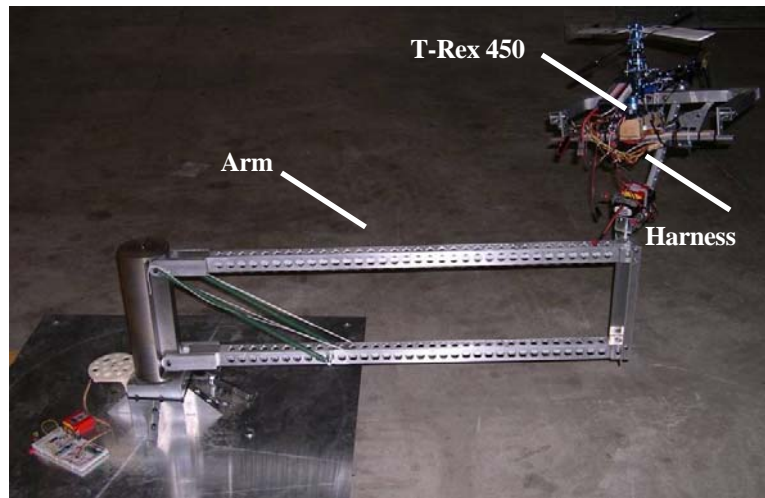
Figure 3: Ground-based Flight Test Stand with T-Rex 450

strut, which compensated for arm weight. The stand's harness can accommodate URVs having rotor diameters of 0.6 to 1.5 m. The URV movements allowed by the test stand appear in Table I. Initial flights to assess the test stand were carried out with a small URV, the T-Rex 450, which was mounted on the test stand as shown in Figure 3. Manual flights were performed first. Then system identification experiments were performed to develop controls for stabilizing the URV autonomously on the ground test stand [6]. Also, a previously developed microcontroller-based autopilot [7,8] (ARL Open Autopilot) was modified for experiments on the stand with the T-Rex 450 URV. This autopilot allows custom control software to be written and developed quickly. It is also small enough and light enough to be flown on the T-Rex 450.

Current operational procedures for UAVs prohibit flying an unsafe aircraft. Using a ground test stand allows operation of URVs having airframes with structural flaws and enables testing of real-time structural health monitoring sensors and flaw detection systems. The stand was enclosed in a safety cage to minimize potential risk. A portion of the cage is visible as shown behind the RMAX in Figure 1. The stand and cage aim to allow the selected URV to achieve autonomous captive flight to accumulate flight hours without the need to conduct free flight testing, reducing risk and cost for experiments with HUMS on defect-embedded rotorcraft components.

As a testament to the benefit of ground test stands and flight safety, during an experiment with a T-Rex 450 URV, the tail rotor belt broke. In free flight, the URV and autopilot may have been irreparably damaged. On the test stand, the URV spun briefly and harmlessly in the harness. Only the belt needed to be replaced in order to continue the experiments.

The harness allows the URV to pitch, yaw, and, roll, but its attachment points define axes of rotation, which do not pass through the center of gravity of the URV. Hence, the harness does not permit the same rotation of the URV, which would occur in free flight. To allow natural rotation, a custom harness needs to be fabricated for each URV, and the URV airframe will possibly need to be modified to accommodate the proper attachment points to mitigate the effect of the constraints. Issues will still remain with different vibration frequencies being generated in captive flight versus free flight. Additionally, it requires precise navigation to follow the constrained path of the test stand to minimize forces generated by the test stand and acting on the URV.

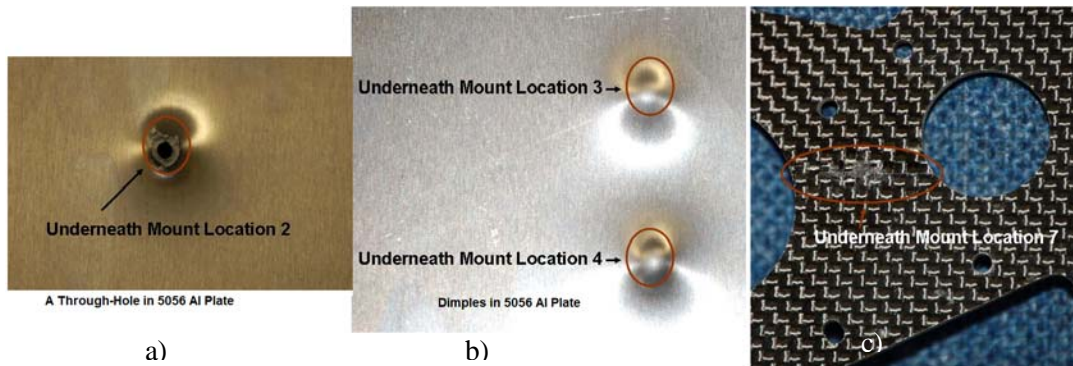
Table II summarizes the test parameters and damage achieved in each flaw initiator test. A typical hole and typical dimples appear in Figure 4a) and b). The flaw created on the carbon fiber composite side plate using the micro-explosive device appears in Figure 4 c), in which a crack along with possible underlying delamination, not readily visible, connects the two holes. Results were most sensitive to the presence/absence of the butterboard attenuator. In aluminum, the butterboard moderated damage from a through-hole to a dimple while, in composite, the crack width was decreased from 7/16 inches to 1/8 inches wide (11 to 3 mm). Because the detection of a crack in metallic components is an important SHM problem, neither the through-holes nor the dimples induced on the aluminum are entirely satisfactory.

Figure 4: a) & b) Underneath M100 Test on Flat Al 5056 Plates c) on Composite Raptor 90 Side Plate

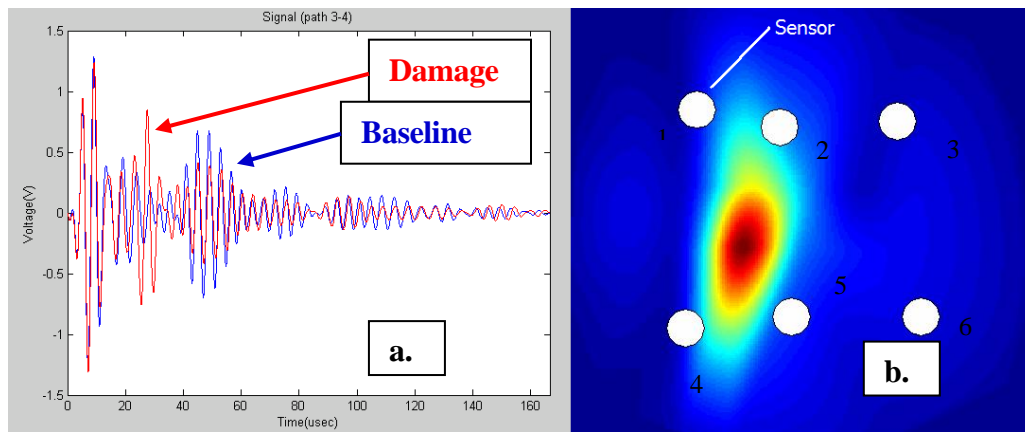
The Lamb waves generated by transducer 3 and the sensor signal received by transducer 4 is shown in Figure 5 a). The sensor locations and numbers are illustrated in Figure 5 b). Transducers 1, 2 and 3 were used as actuators and transducers 4, 5, and 6 were used as sensors, resulting in a total of 9 actuator-sensor paths that formed a grid encompassing the target damage detection monitoring area. The baseline data, collected before initiation of damage, appear in blue while the post-damage data appear in red. Acellent ACCESS software post-processed data from the 9 actuator-sensor paths, which have been used to generate the diagnostic image, appears in Figure 5 b). Contour colors graduate from blue to red to indicate the probable damage location. The Acellent's data collection hardware uses discrete actuator and sensor connectors, facilitating low noise/low crosstalk signal generation and capture. Close sensor spacing can be utilized without signal degradation, allowing for high-resolution damage detection.

Figure 5: a.) Baseline and Post-Damage Data b.) Post-processed Image
